RESULTS OF 2010 ARCHAEOLOGICAL INVESTIGATION  
LATHROP HOUSE BASEMENT  
PAUL REVERE MEMORIAL ASSOCIATION  
BOSTON, MASSACHUSETTS

Submitted to:  
Paul Revere Memorial Association  
Boston, Massachusetts

Prepared by  
Kathleen Wheeler, Ph. D.,  
and  
Jessica Kramer

IAC Report # 1011  
December 17, 2010

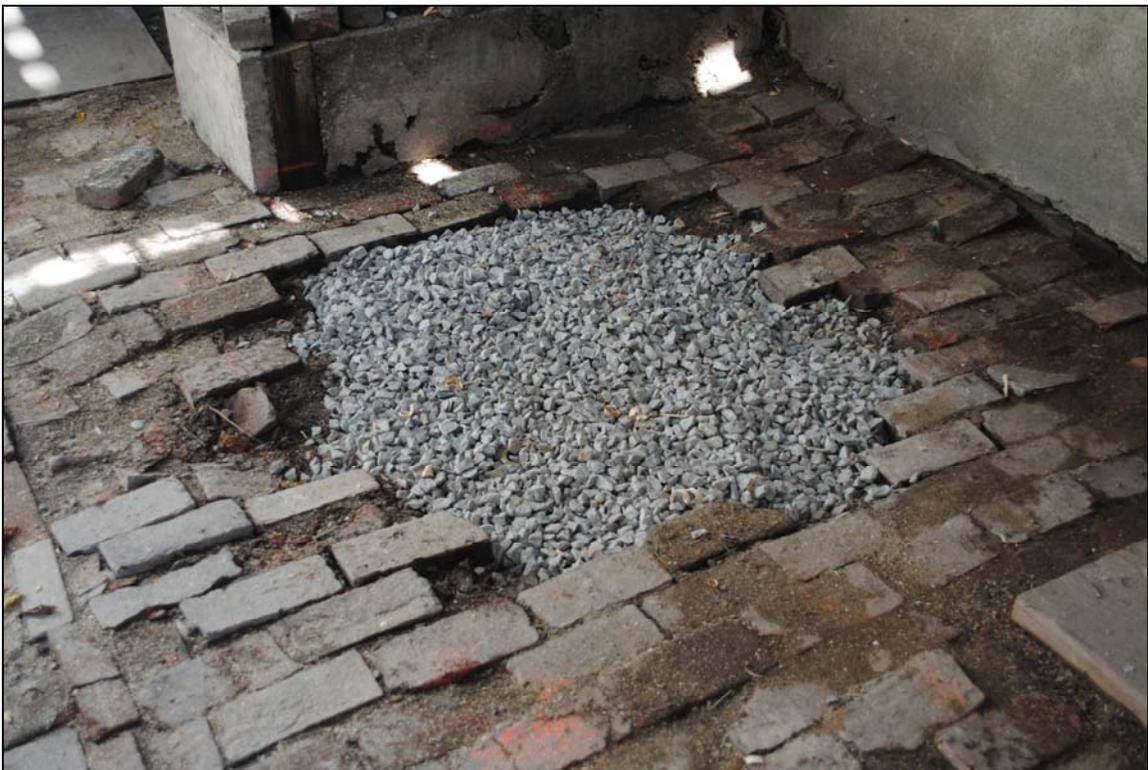
Plate 1. Locus 12 drainage pit dug in courtyard, view NW.

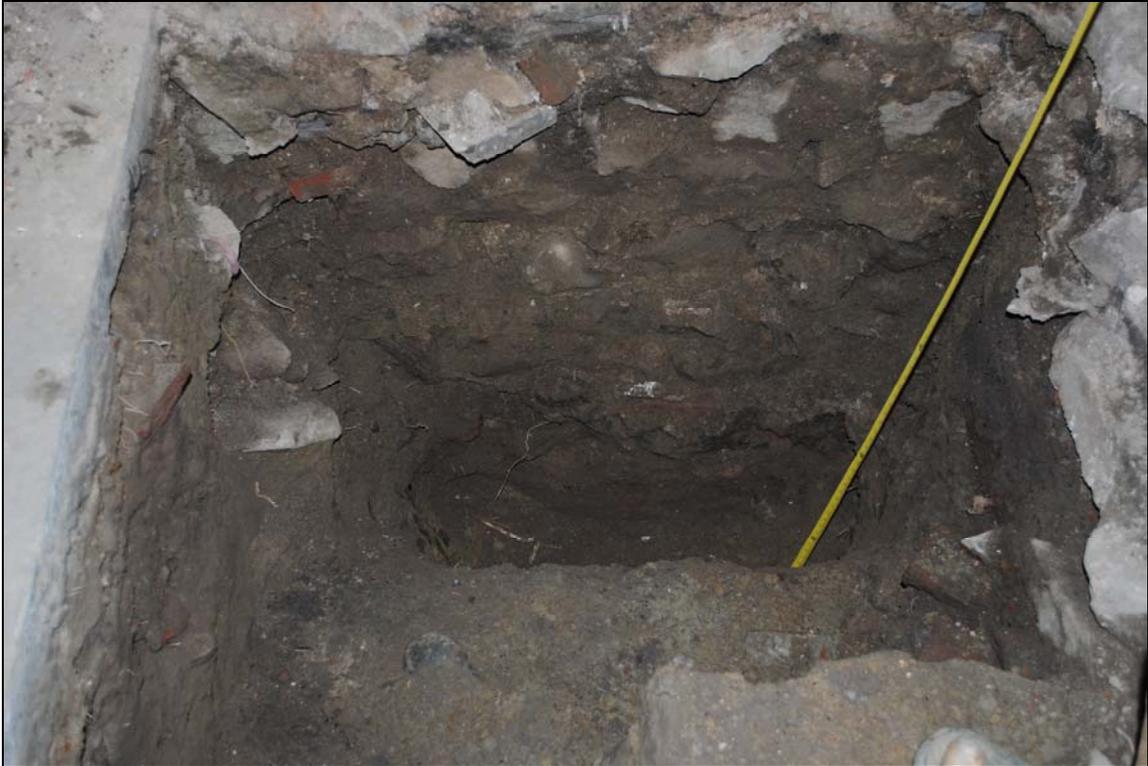
Plate 2. Exploratory trench ending at 1.3 m (4.2 ft) below the pavement floor, along eastern margin of foundation wall.

As shown in Figure 3, N202.3 E207.5 is in the southeast corner of the cellar, and is bound to the south by a cinder-block foundation wall and to and east by a mortared fieldstone foundation wall. The east unit measured 1.3 m (4.2 ft) by 1.25 m (4.1 ft), and was excavated to an ending depth of 0.65 m (2.1 ft) below the concrete pavement, which reached the base of the southern cinder-block wall. IAC excavated a narrow trench against the east foundation wall to a final depth of 1.3 m (4.2 ft) [Plate 2], where the base of the foundation wall was not exposed.

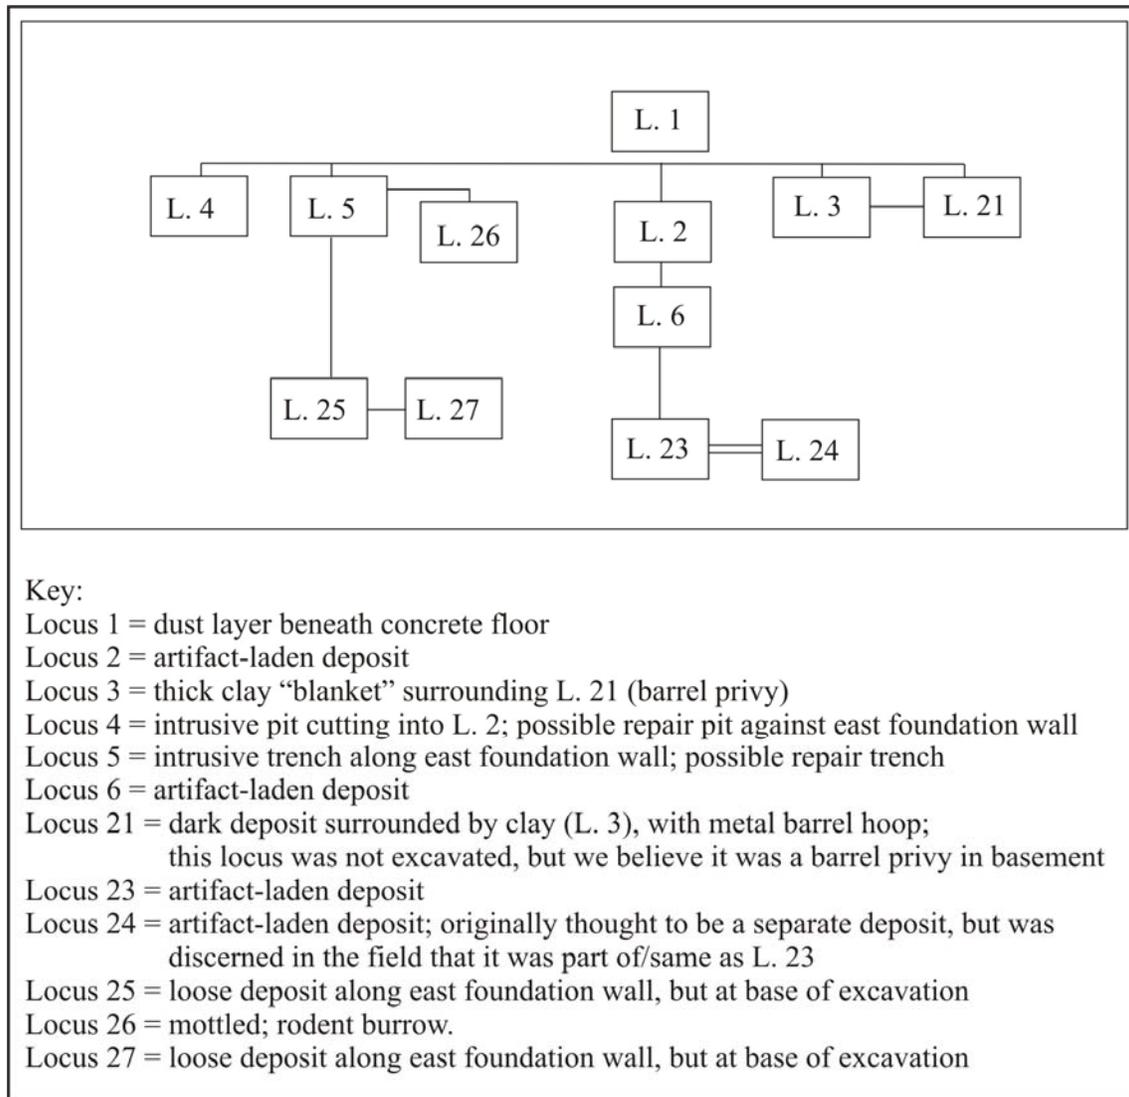
Figure 5. Harris Matrix for N202.3 E207.5, showing the stratification and relation of 13 loci.

Archaeologists excavated this unit over the course of two field days, identifying 13 loci (Loci 1-7, 21, and 23-27), including what appears to be a clay-packed (L. 3) metal-hooped barrel privy (L. 21) in the southwest corner of the east unit (Plate 3). Figure 5 is a Harris Matrix of the 13 deposits, showing how each of them related to one another. Prior to excavation, archaeologists scraped the surface of the EU to aid in the identification of underlying features or loci. The uppermost deposit surface was designated as Locus 1, a dark gray (10YR 4/1) silty clay loam of loose compaction; i. e., the dusty layer immediately beneath the concrete floor.

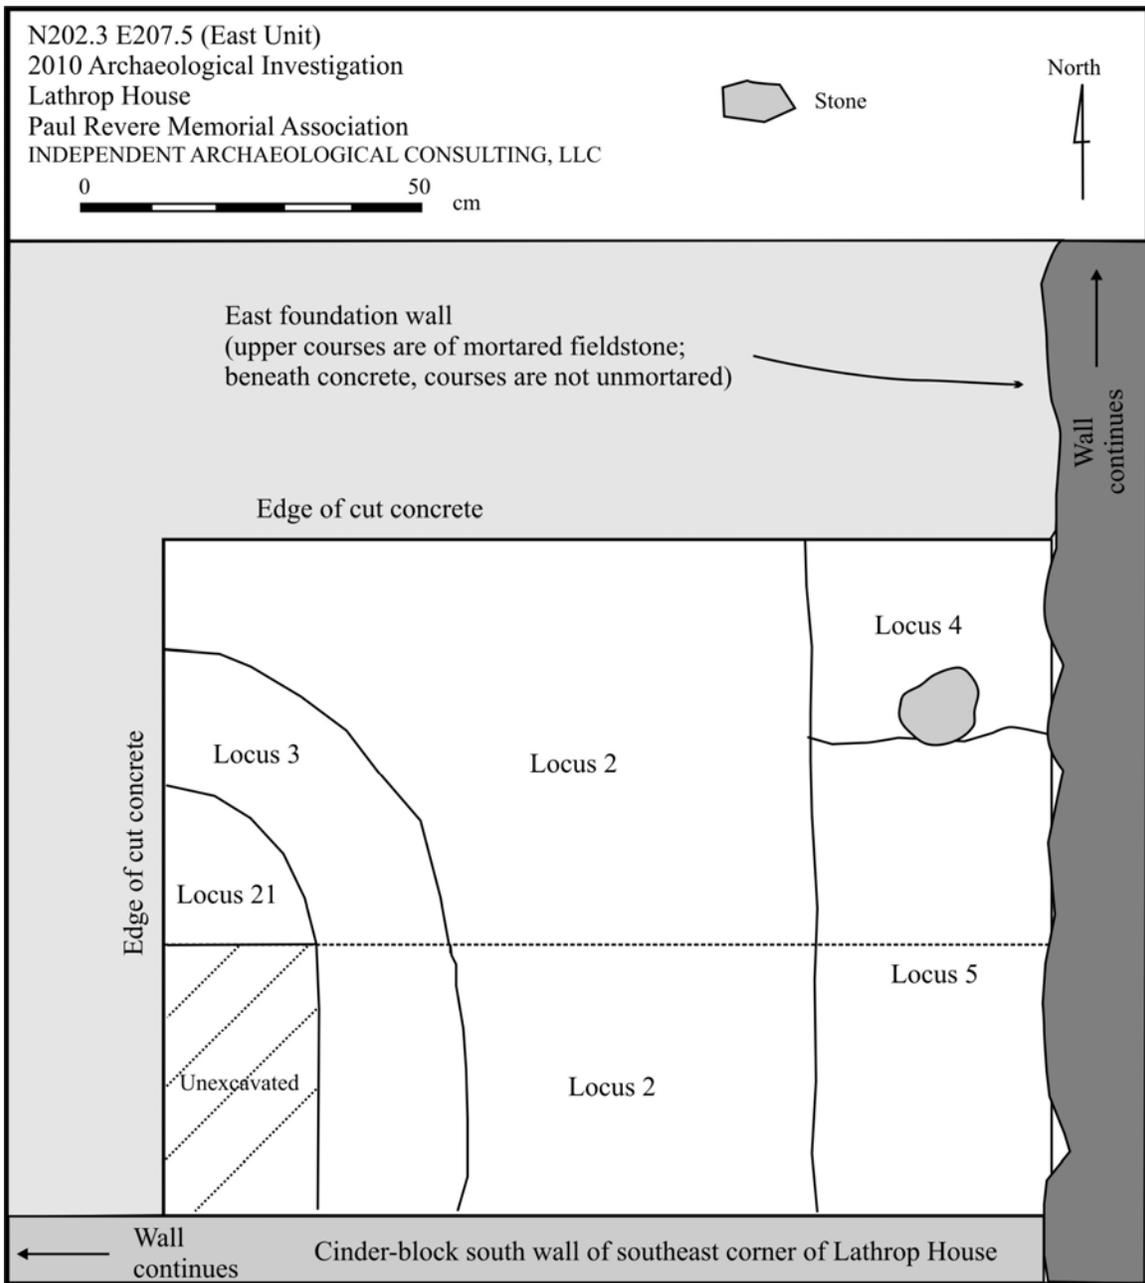
Figure 6. Location of excavation unit N202.3 E208.1 in southeast corner of Lathrop House cellar. The figure shows the various loci exposed immediately beneath the Locus 1 “dust” layer.

At 18 cm (7 in) below the basement concrete floor, archaeologists identified five additional loci (Figure 6). Locus 2 (L. 2) is an artifact-laden deposit composed of a dark gray (10YR 4/1) silty clay loam of moderate compaction, and covers the majority of the floor of the EU. Several ceramic sherds with a variety of ware types were recovered from within L. 2, including sherds of Westerwald, English salt glazed stoneware, and a Nottingham-type fragment embossed with the letters “BOS”. At the western margin of the east unit, Locus 3 (L.3) is a semi-circular clay feature that on the surface appears to be a “plug” or a cap to a down-cutting feature, with a darker area (L. 21) inside the circular deposit of clay (see Figure 6; Plate 3). Locus 3 is a compact, grayish brown (2.5Y 5/2) clay, with very few artifacts. In the opposite corner of the east unit, archaeologists noted a second clay locus in the northeastern corner, identified as Locus 4 (L. 4). Locus 4 is a dark grayish brown (10YR 4/2) silty clay loam of heavy compaction and is bound to the south by Locus 5 (L. 5), and to the west by L. 2. Locus 4 contained several fieldstones, which distinguished it from Locus 5, into which Locus 4 cut.

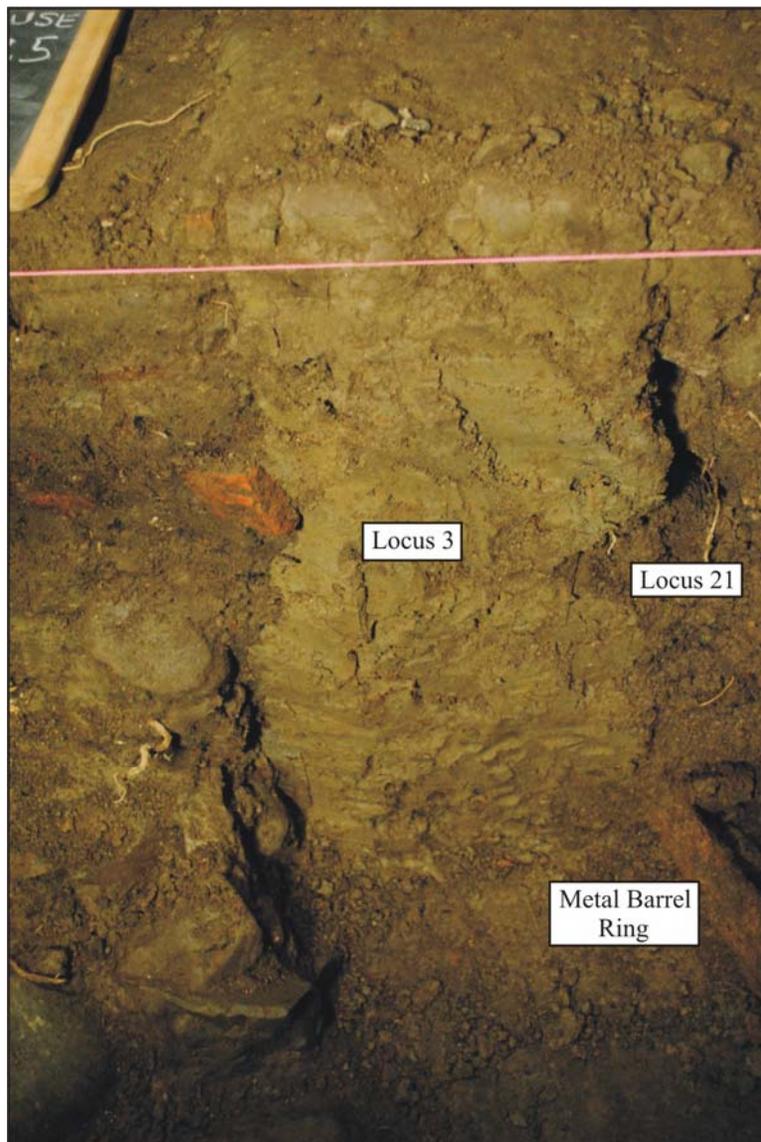
Plate 3. Clay lined barrel privy, packed with clay. View south.

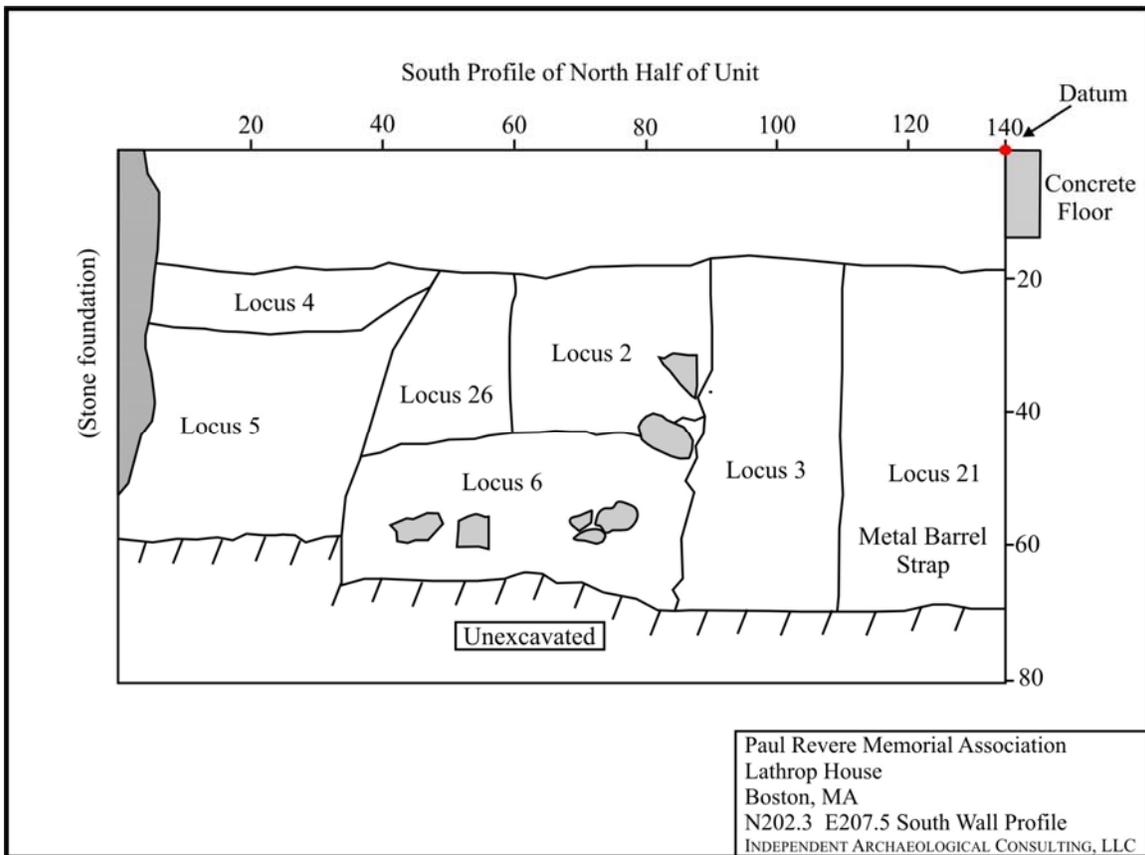
Figure 7. South wall profile of the northern half of TU East N202.3 E207.5.

Due to time constraints and the complex nature of deposits in the east unit, IAC excavated the northern half of the unit during the initial visit, continuing the excavation of the southern half on July 29, 2010. Prior to excavating the north half of the unit, IAC drew the south profile of the excavated northern half, discovering an additional locus (Locus 26) that had not been present in the north half of the unit. The profile drawing is shown as Figure 7.

Archaeologists found a series of deposits with clear horizontal and vertical boundaries that overly one another. To the west is the clay-wrapped barrel privy, which was only partially exposed. Along the eastern cellar wall are at least two downcutting trenches – Loci 4 and 5 – that are probably associated with builders trenches and subsequent maintenance and repair activities. To further complicate the interpretation, archaeologists noted several rodent burrows that cause the intermixture of artifacts. The individual deposits are reviewed below.

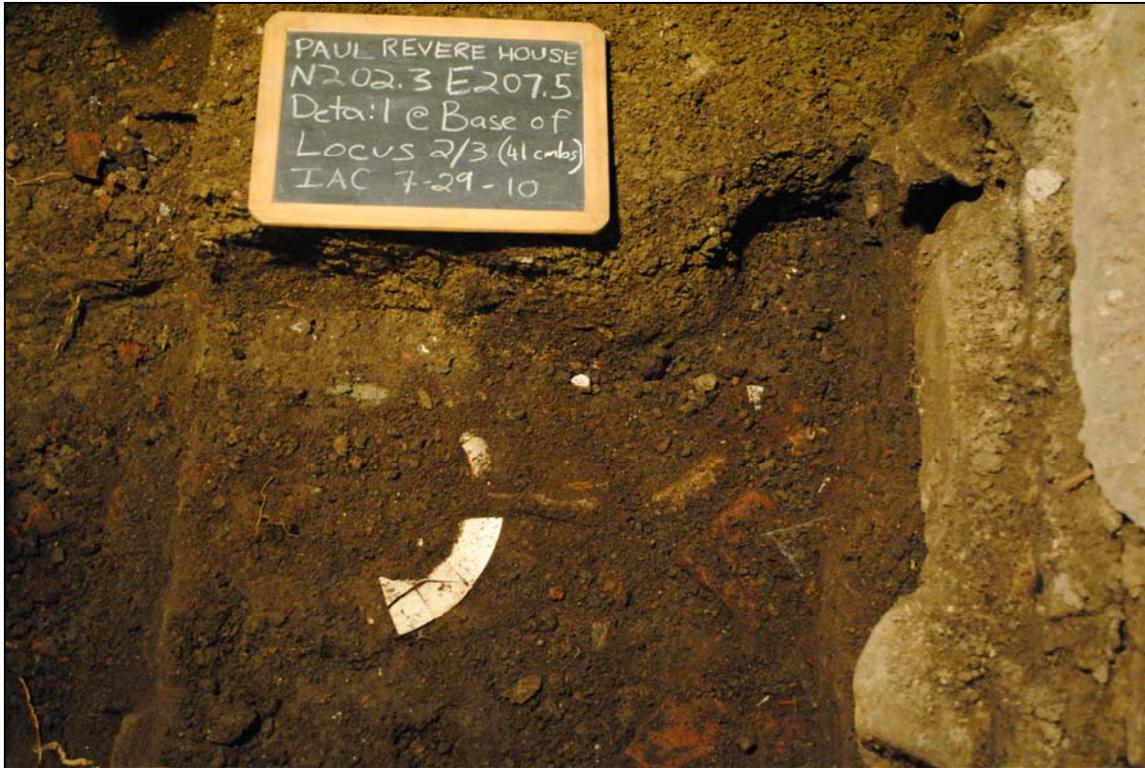
Plate 5. Ceramic plate sherds at interface of Loci 2 and 6 at 41 cmbs.

Locus 2 formed a clear wavy boundary with the underlying Locus 6. Locus 6 is a gray (10 YR 5/1) silty clay loam of moderate compaction. At the interface between Loci 2 and 6, several large ceramic sherds were noted. Locus 6 was a fairly thin stratum (41-48 cmbs) and forms a clear wavy boundary with the underlying Locus 23.

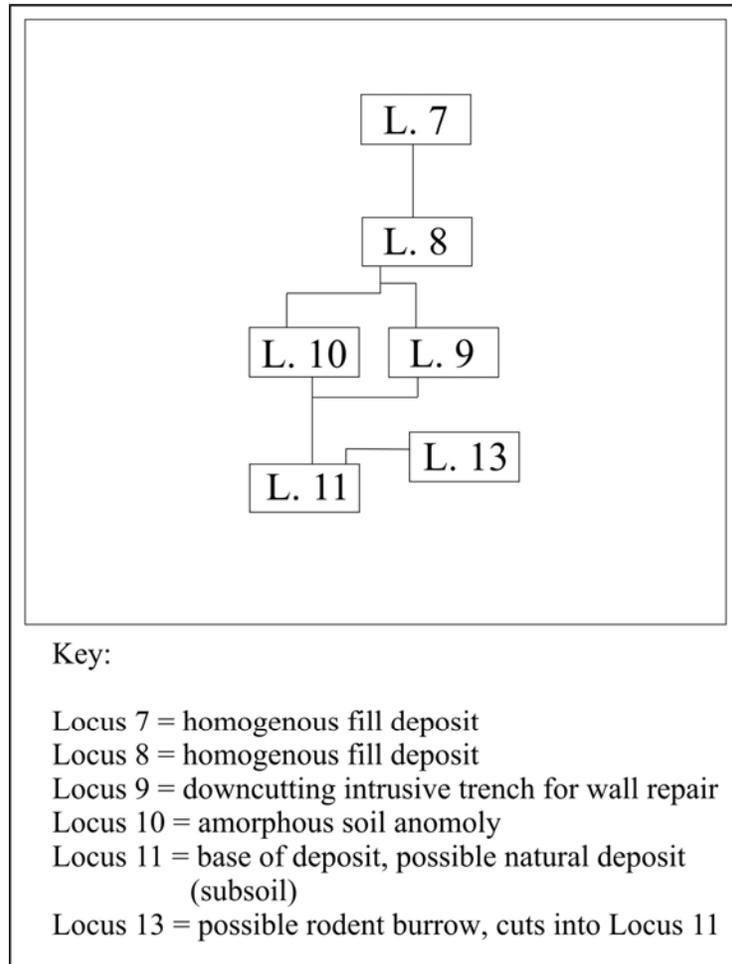
Figure 8. Harris matrix for N200 E200, showing the stratification and relation of six loci.

N200 E200 is located in the extreme south west corner of the cellar, and is bound along the south and west walls by a mortared field stone foundation and associated cellar walls (Figure 3). Both walls show evidence of recent repair attempts using concrete. Located along the southern wall is a mortared fieldstone foundation underlying the cellar wall, this foundation created a lip that extended 20 cm north into the EU. The EU with the lip included, measures 110 cm east-west and 120 cm north-south, and was excavated to a depth of 85 centimeters below the modern concrete floor. Archaeologists identified a total of six Loci (Loci # 7-11, and 13) in N200 E200 (Figure 8). Figure 7 is a Harris Matrix of the six deposits, showing how each of them related to one another.

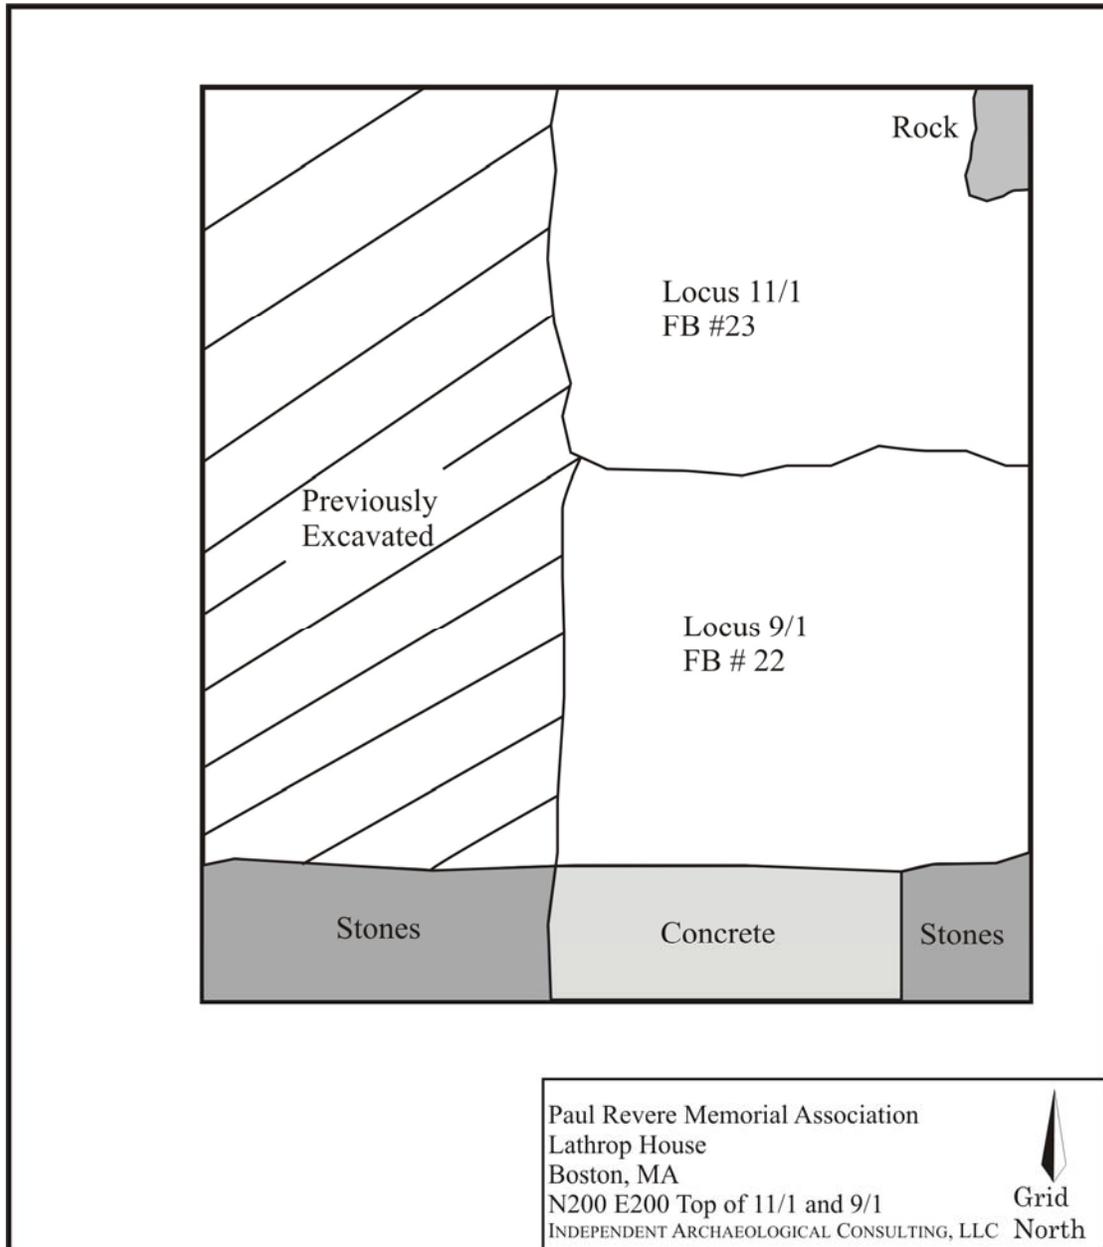
Figure 10. N200 E200 with Loci 9 and 11 exposed.

redware sherds. Archaeologists identified Locus 9 as a builder's trench associated with maintenance or repair along the southern foundation wall, as it was oriented parallel to the wall (Figure 10) and had a sharp vertical interface.

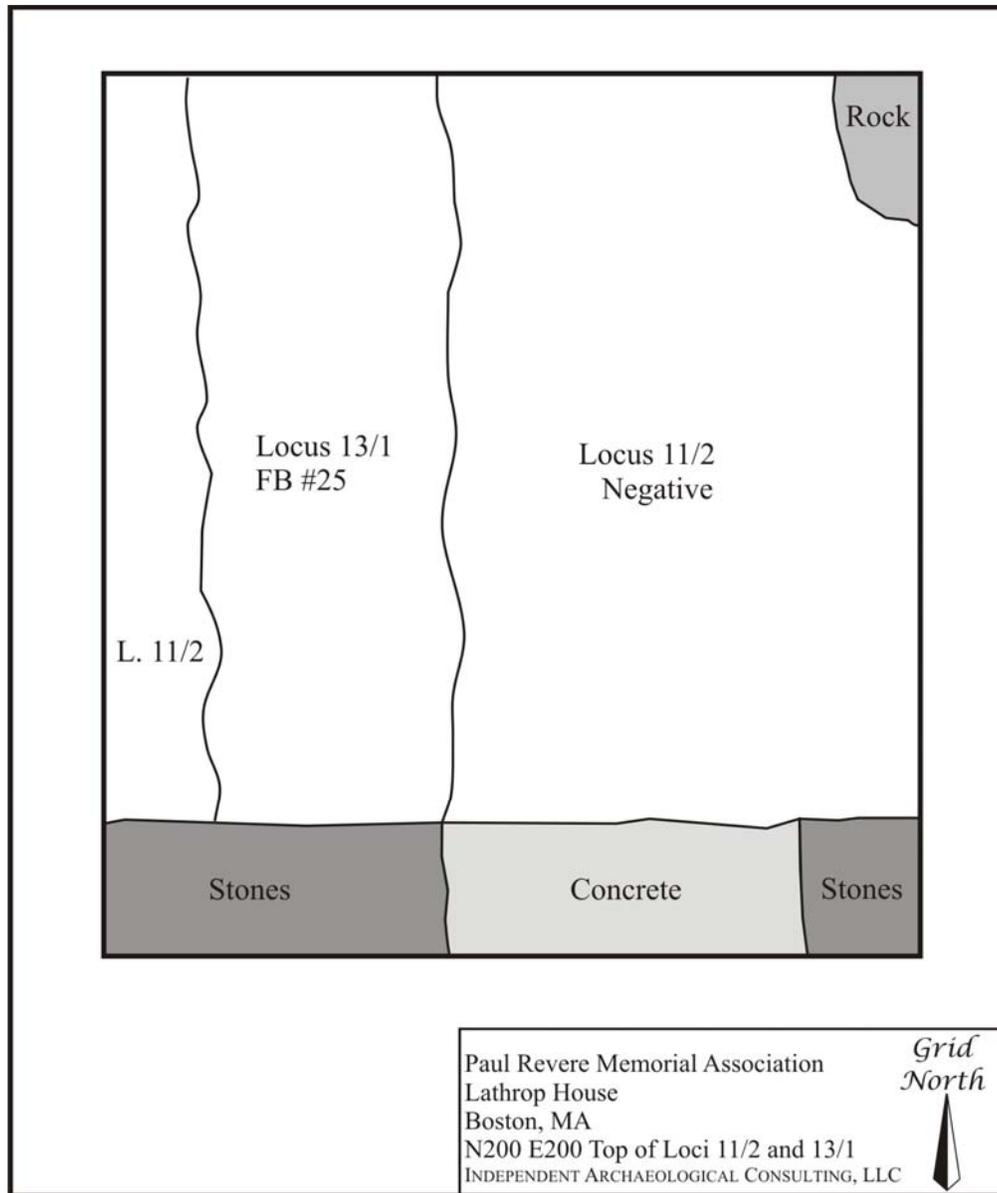
Figure 11. Base of N200 E200 with beginning elevations of Loci 11/2 and 13/1.

At the top of the second level of Locus 11 (11/2), IAC had brought the EU down to the same elevation, where they encountered Locus 13 along the western margin of the test hole (Figure 11). Locus 13 is a very dark grayish brown (10 YR 3/2) silty clay of moderate compaction, which intruded into Locus 11 and was sandwiched between L. 11/1 and L. 11/2. Archaeologists identified Locus 13 as a rodent burrow. Archaeologist recovered few artifacts from L. 13, and these were a piece of window glass, a mammal rib, a mold made brick fragment and a sherd of earthenware ceramic with a blue handpainted tin glaze.

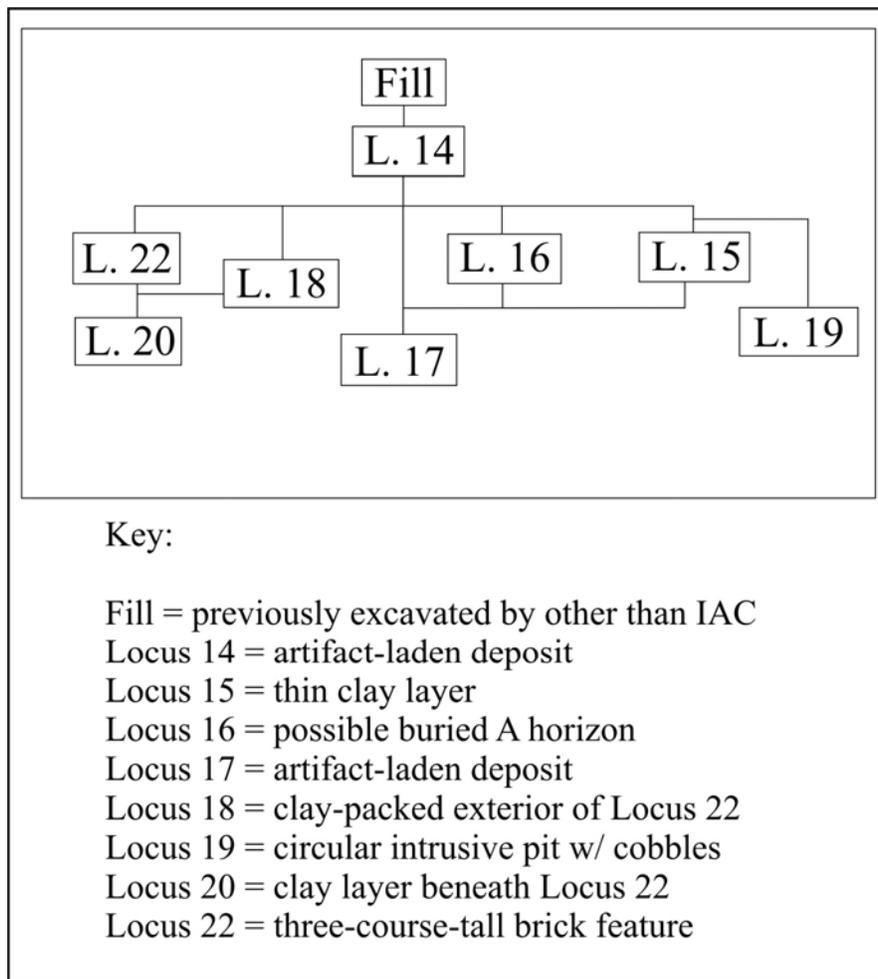
Figure 13. Harris matrix for N208.3 E208.1, showing the stratification and relation of eight loci.

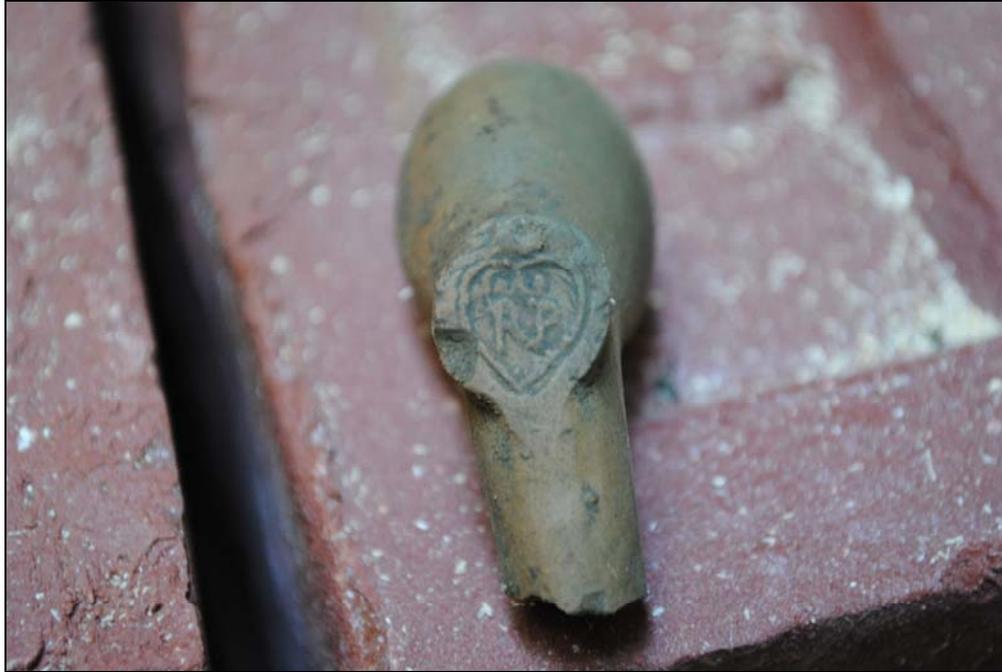
Plate 7. Photo of Redware Pipe with “RP” stamp recovered from L. 14/1.

L. 14/1 were brick fragments, mammal bone, salt glazed stoneware, Westerwald, redware, white granite, Nottingham sherds, wire nails, bottle glass, lamp chimney sherds, a mammal tooth, and a small piece of lead. An intact red clay pipe bowl with the stamped letters “RP” within a heart shaped emblem was collected from within Locus 14 (Plate 7).

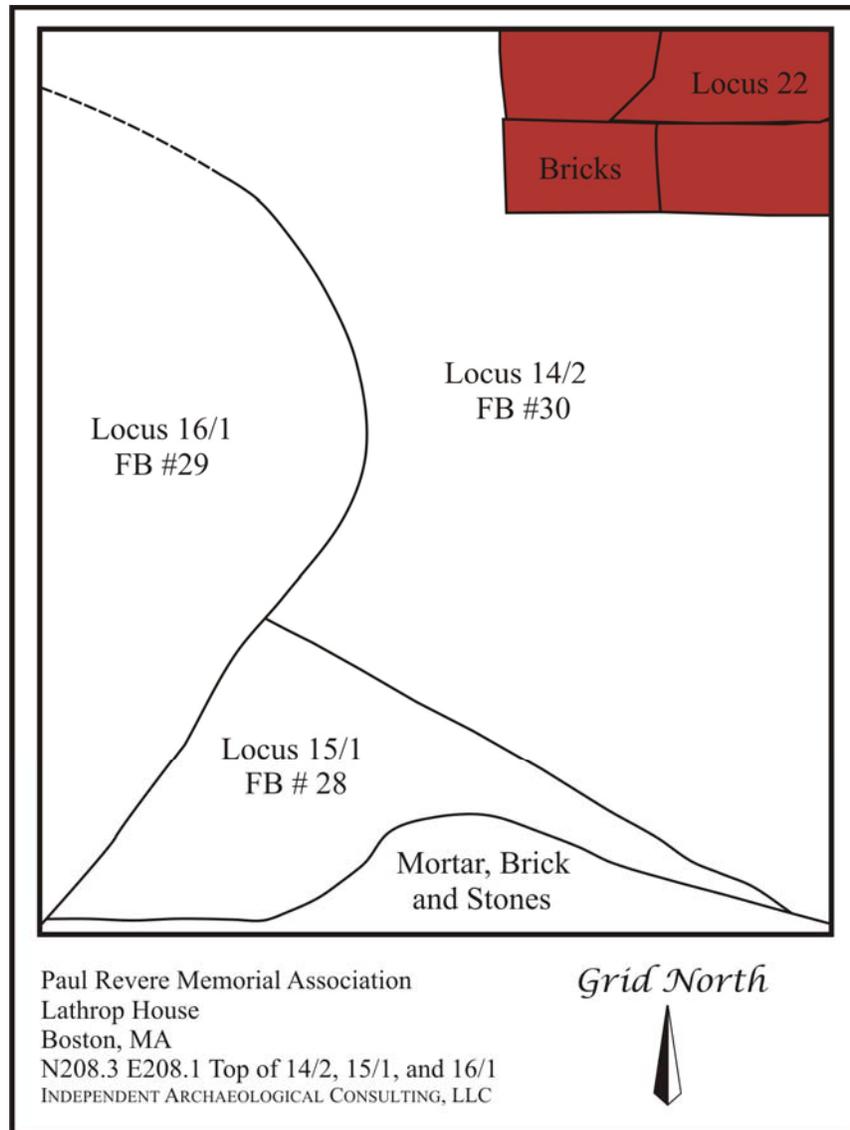
Figure 14. N208.3 E208.1, top of Loci 14/2, 15/1 and 16/1.

After cleaning off the loose debris, three loci were identified. Locus 15 (L. 15/1) was encountered at 49 centimeters below datum (cmbd), along the southern margin of the EU. The Locus formed a right angle with Locus 16 (L. 16/1) to the northwest, and L. 14/2 to the northeast. Locus 15/1 was primarily composed of a grayish brown (2.5Y 5/2) clay of moderate to heavy compaction, mottled with a olive brown (2.5Y4/3) silty clay loam. Within Locus 15/1 a number of late 18<sup>th</sup> century ceramic sherds were recovered, including delft, salt glazed English stoneware, Jackfield and the fragments of a creamware soup plate. Locus 15/1 terminated at 59/62 cmbd when Locus 17 (L. 17/1) and Locus 19 (L. 19/1) were encountered.

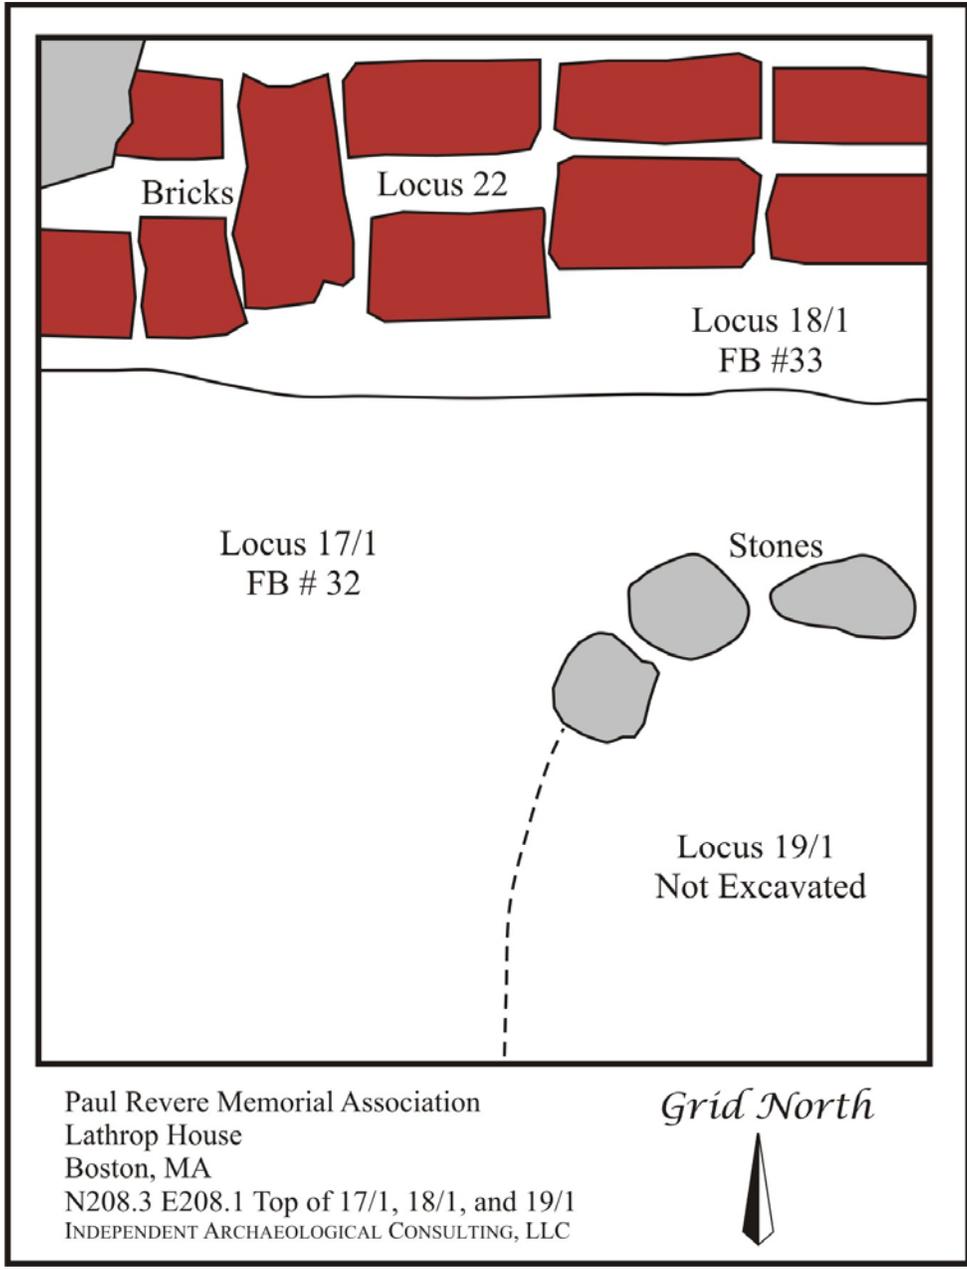
Figure 15. N208.3 E208.1, top of Loci 17/1, 18/1 and 19/1.

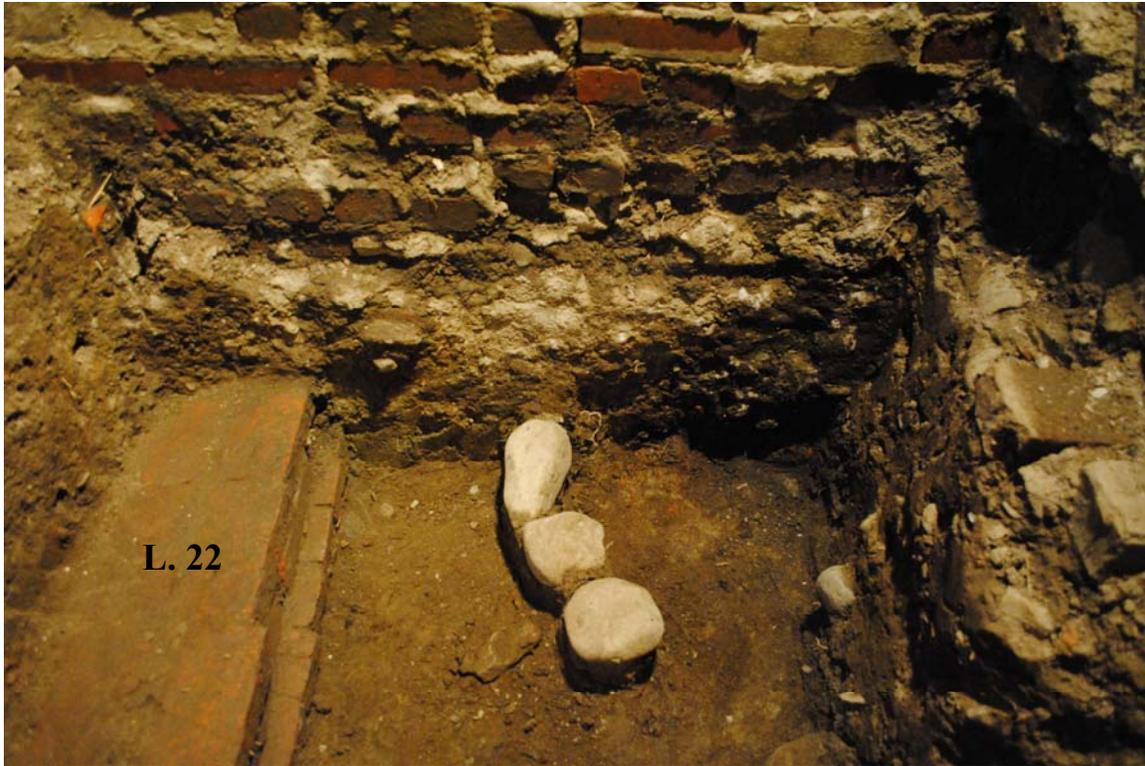
Plate 8. N208.3 E208.1, Loci 19 and 22, view east.

Located in the south eastern corner of N208.3 E208.1 is a semi-circular arrangement of small cobbles that line the perimeter of Locus 19 (Plate 8). Locus 19 is underlying Locus 14/2, and was encountered at 72 cmbd. A single artifact, a sherd of English salt glazed stoneware with a diaper pattern, was noted and collected at the 72 cmbd, on the surface of Locus 19. Unfortunately, excavation of Locus 19 was beyond the scope of this project. Excavation of the entire EU ceased at 72 cmbd when a sufficient depth of 25 below the last course of stones in the south and east foundation walls had been achieved and verified by Nina Zannieri.

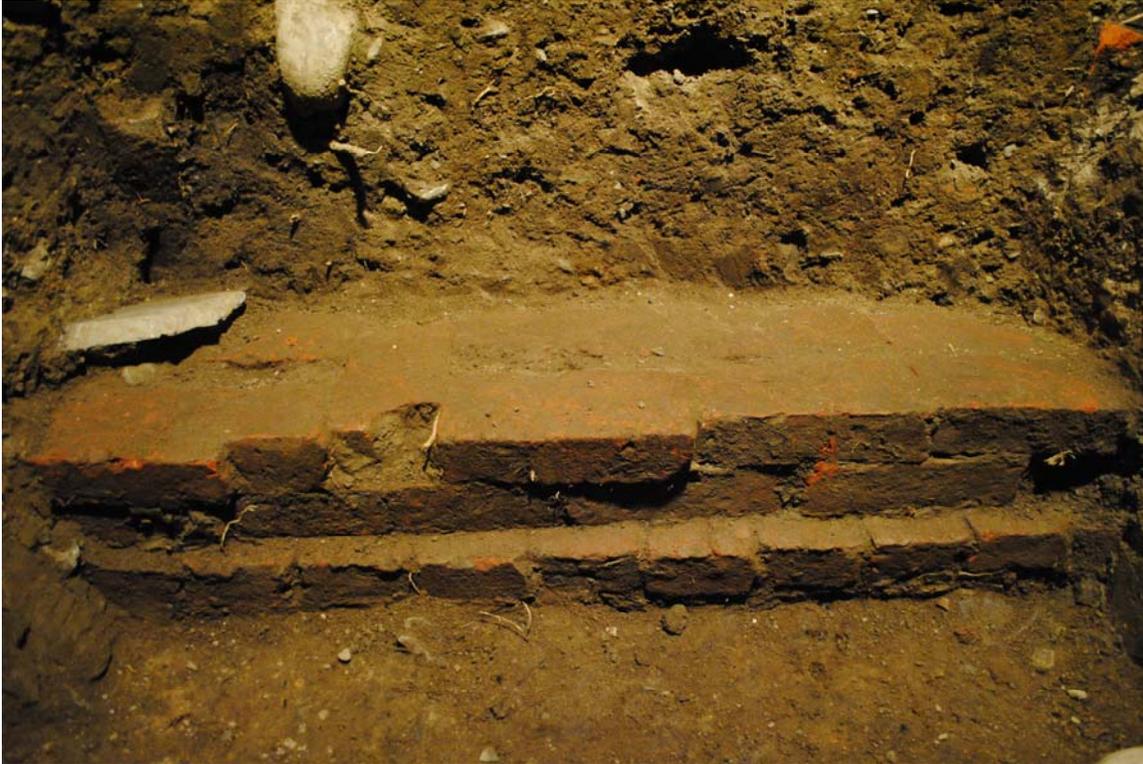
Plate 9. Locus 22, brick feature oriented north-south along eastern margin of N208.3 E208.1.

Located along the margin of the north wall and oriented east-west, a lineal arrangement of four bricks was encountered at 59 cms and was retroactively assigned the Locus number 22. Further excavation revealed that Locus 22 ran the length of the EU and was comprised of three courses of brick (Plate 8 and 9). Packed along the southern margin of the brick wall was a layer of grayish brown (2.5Y 5/2) clay of heavy compaction, identified as Locus 18 (L. 18/1). Archaeologists recovered very few artifacts from L. 18/1, a mammal bone fragment and a single piece of brick. Underlying the lineal arrangement of bricks is Locus 20, a stratum of dark olive brown (2.5Y 3/3) silty loam of loose to moderate compaction. Locus 20, like Locus 18 is oriented east-west and is only visible in the profile of the north wall.

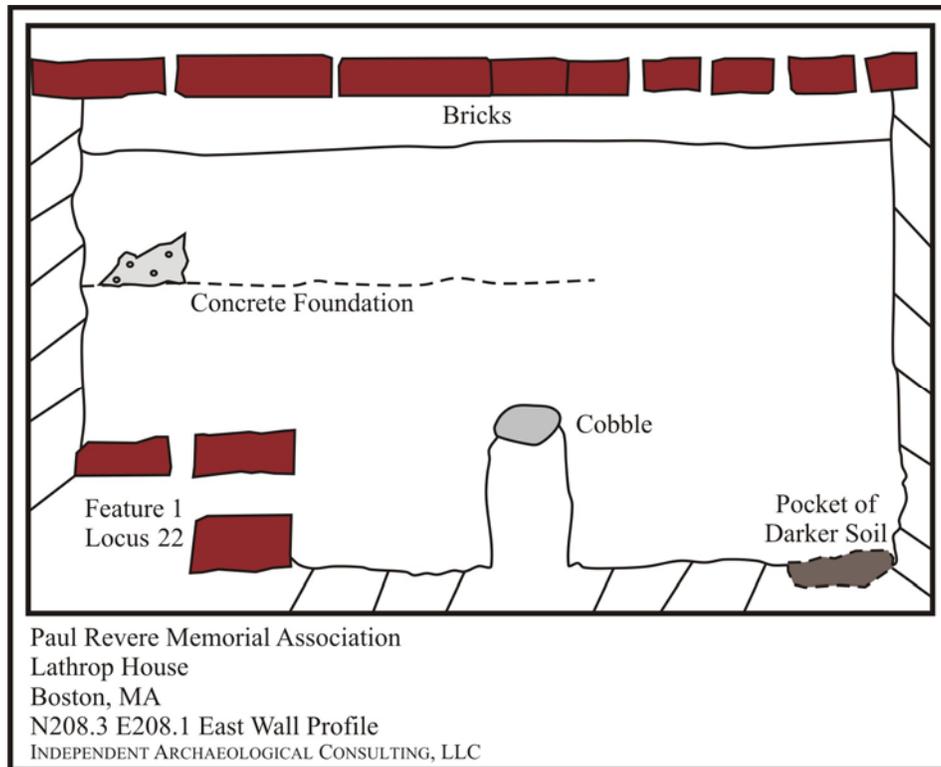
Figure 16. N208.3 E208.1 East Wall Profile

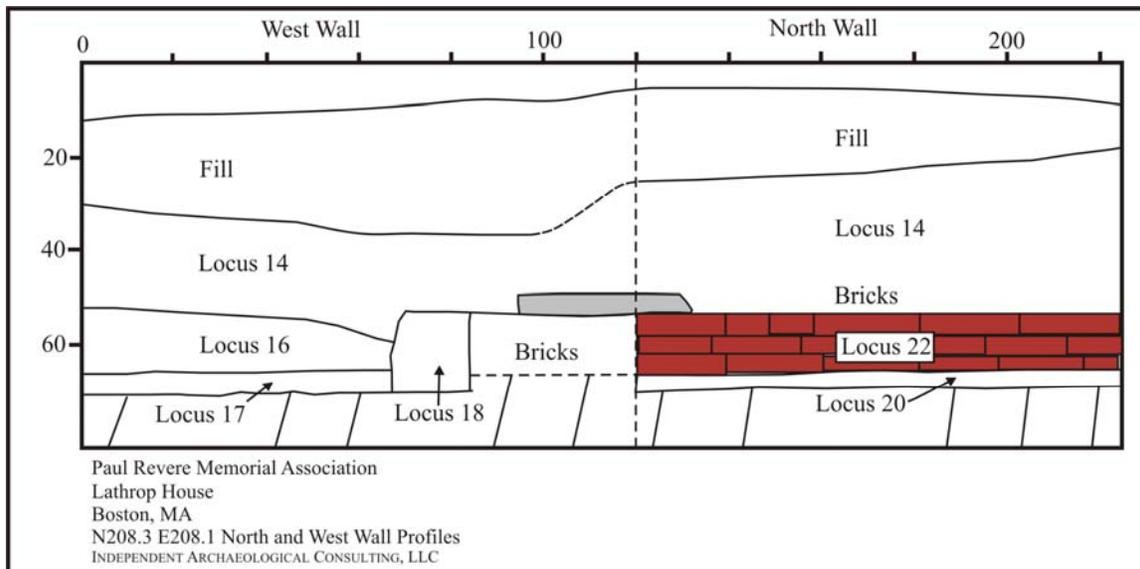
Figure 17. N208.3 E208.1 North and West Wall Profiles.

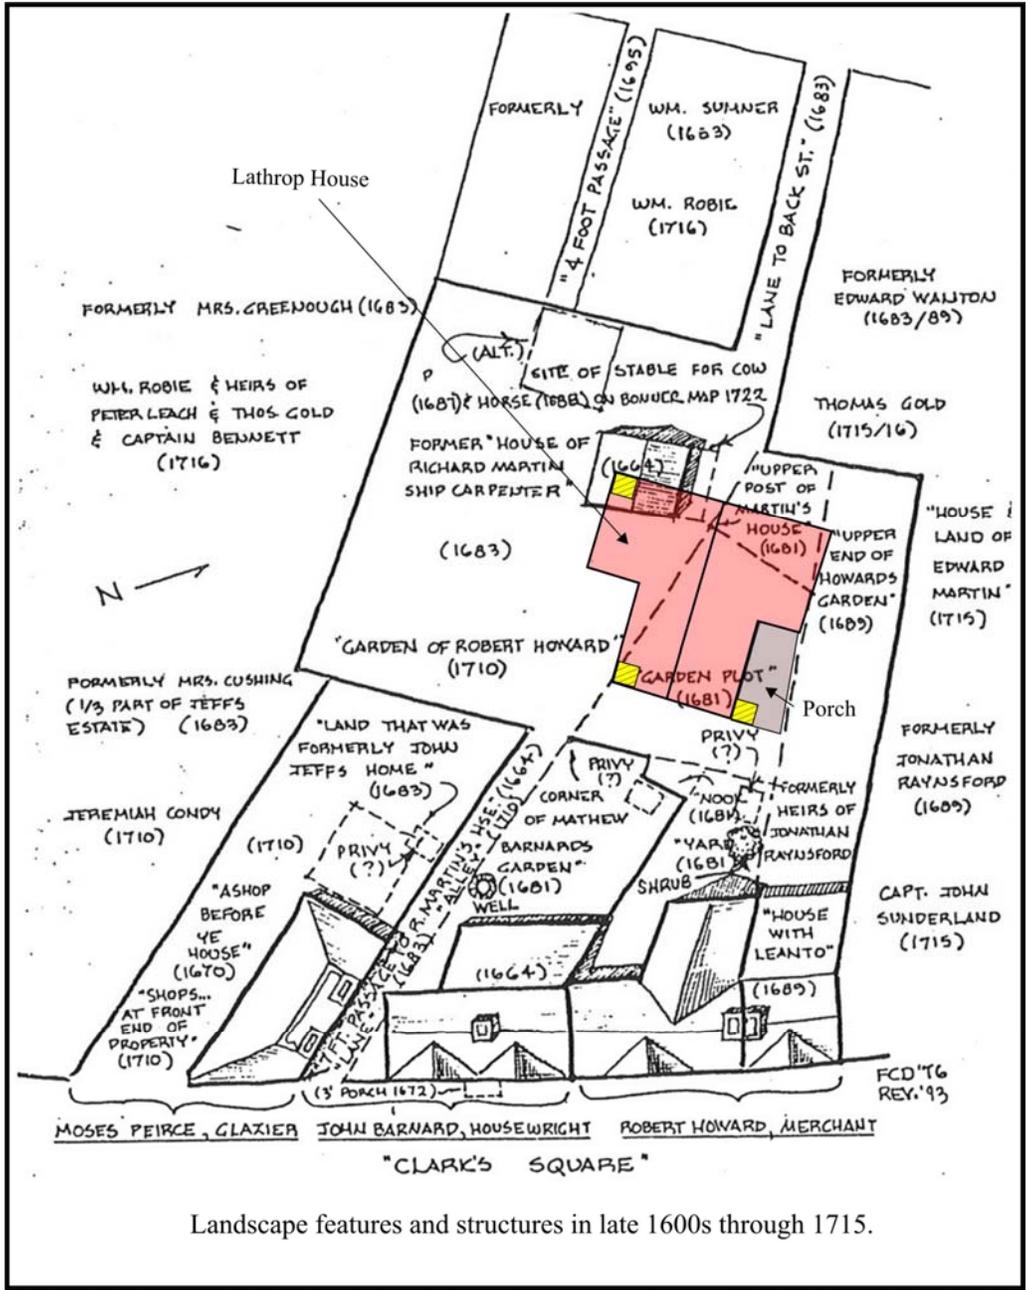
Figure 18. Approximate location of Lathrop House and 2010 excavation units compared to 1715.

In the 1600s, the north and east excavation units fall in the back garden, while the south EU lies relatively within the "Site of stable for cow and horse," dated 1664 (see Figure 18). Two privies are shown at the back of each of the lots attributed to John Barnard (housewright) and Robert Howard (merchant). The merchant, Howard, had ample opportunity and finances to import the best in English and German ceramics, found at the site in Westerwald and Rhenish stonewares, English white salt-glazed stoneware and buff-colored coarse earthenware. Remnants of these wares, along with broken bottle glass, and refuse from food production (bones, shell) were likely thrown out in the backyard and incorporated in the garden.
